Karuk Watershed
Restoration Program
Tribal Nonpoint Source Program Workshop
2007

Implementing NPS Projects on a Watershed Scale

**Karuk Watershed Restoration Program
Bluff Creek Watershed Restoration**

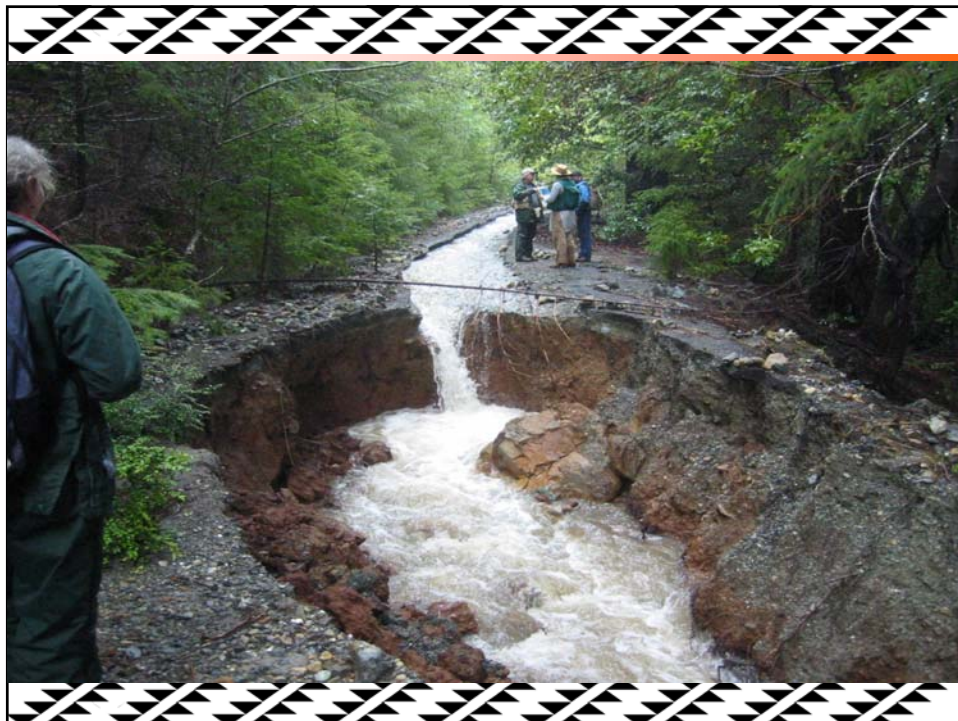
Road failures were found to be significant sources of sediment to anadromous streams in Bluff Creek

- Mass wasting associated with large storm events
- Culverts plugged with sediment and debris
- Road locations across sensitive terrain
- Road maintenance concerns

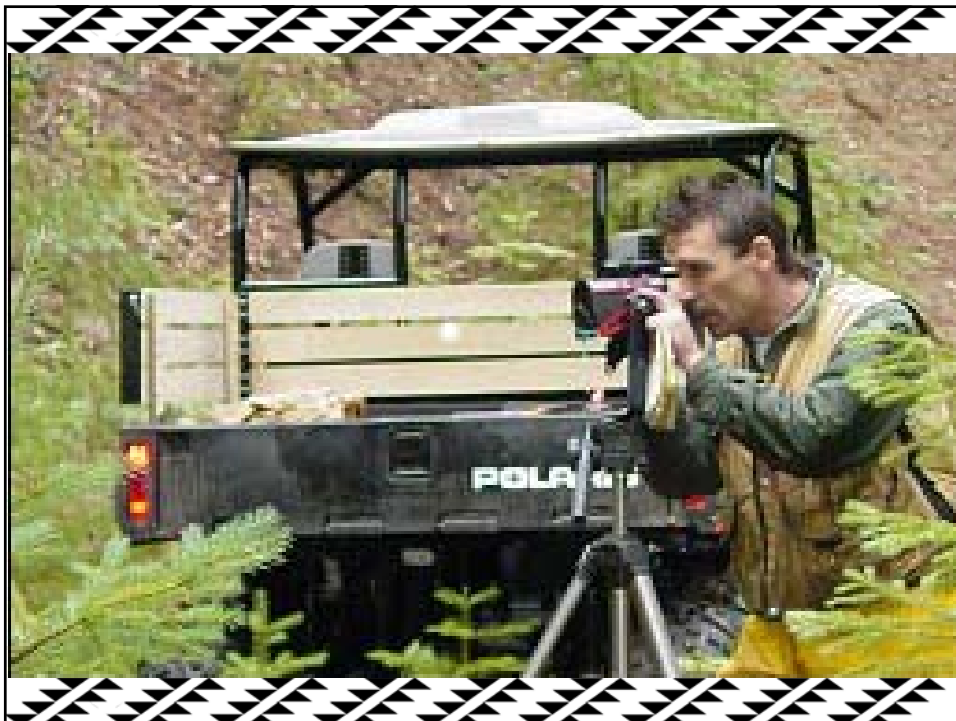
Field Inventories at the watershed scale

- Assessment of road condition and geology
- Proximity to Domestic Water Intake
- Proximity to anadromous fish habitat
- Number of sites ranked high for treatment or needing maintenance
- Risk of stream crossing diversions
- Risk of road surface erosion at crossings
- Adequacy of road drainage between crossings
